Sanctuary Housing Development Utilizes MICROBE-LIFT® Technology on Seven Lakes in Jacksonville, FL

Location: Sanctuary Housing Development, Jacksonville Beach, FL

Background: After a dramatically successful remediation of a pond in their upscale housing development using MICROBE-LIFT® technology, the management of this development chose to treat all the lakes within its borders.

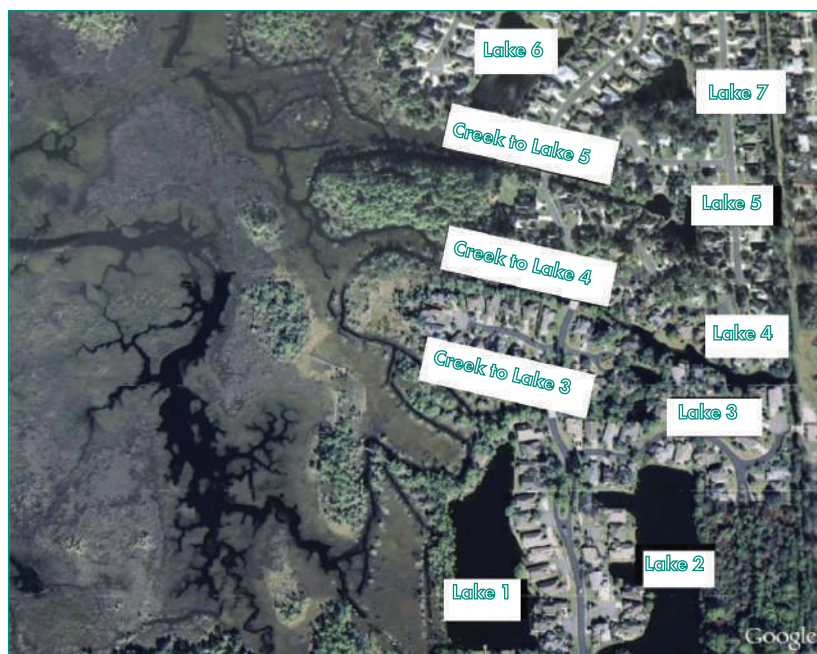
The following picture shows the position of the lakes and the general location of the homes. Lake two was the first lake treated with "before" pictures taken in February 2007 and "after" pictures taken in October 2007, eight months later.

Fig. 2: Aerial view of the property showing all lakes to be treated, the location of homes, and the relationship to the Intracoastal Waterway.

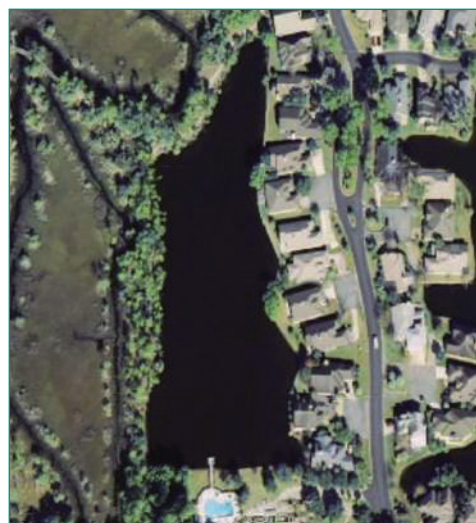
Fig. 3: Overview of Lake #1.

This is a 2-acre lake with a spillway to the Intercoastal Waterway connected by two culverts that will backflow in the event of storms. While there was a healthy, beneficial population of natural plants growing in the southwest corner of the lake, there was erosion along the entire west bank. There was moderate nutrient loading from lawn care companies, run-off and natural debris. This lake had a history of moderate algae blooms

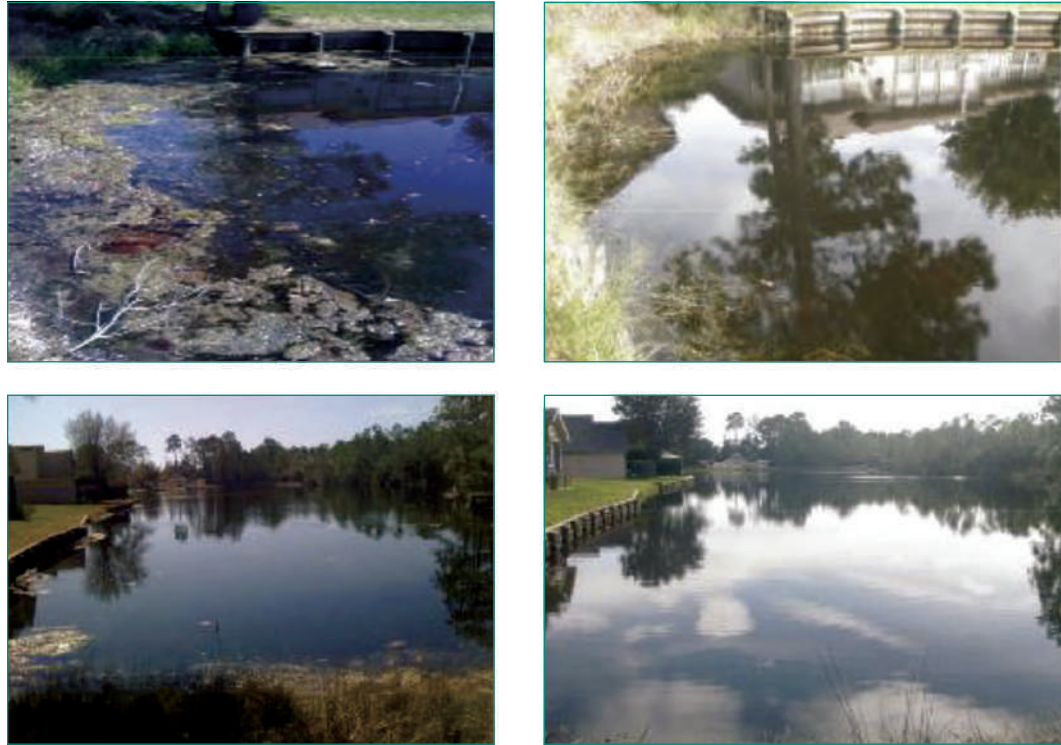
The pictures below show the condition of Lake #1 before and after treatment. The first set of pictures show the north shore of the lake.

Fig. 4: These are pictures of before treatment (left) and after treatment (right). These are views of the north side of lake #1. Surface scum on the left has been completely removed.

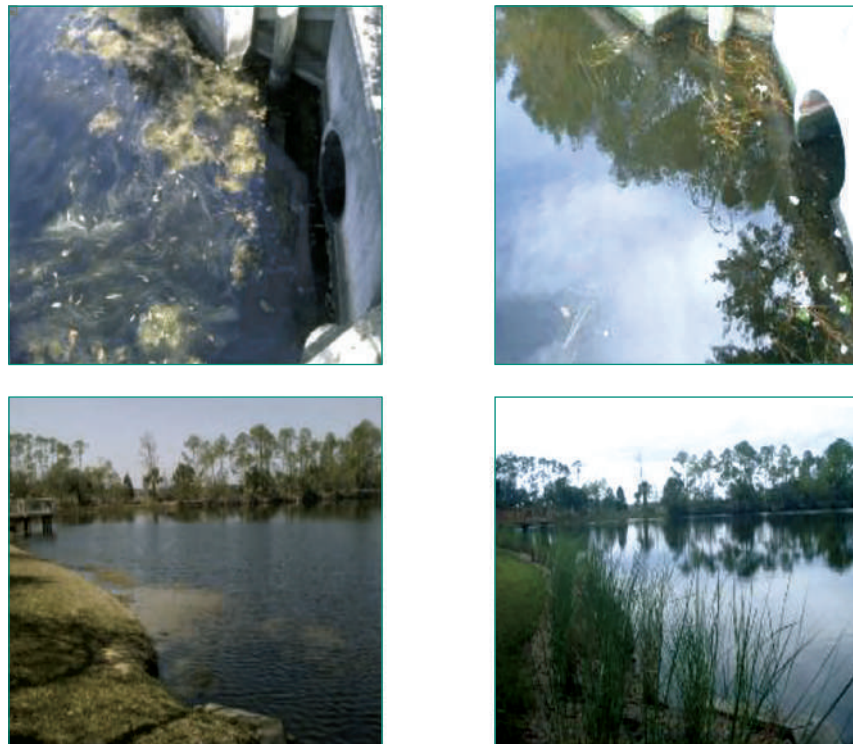
Fig. 5: These pictures show the removal of organic pollutants that were so evident prior to treatment in the pictures on the left versus the clear water in the right set of pictures resulting from MICROBE-LIFT® treatment. This is the south shore of lake #1.

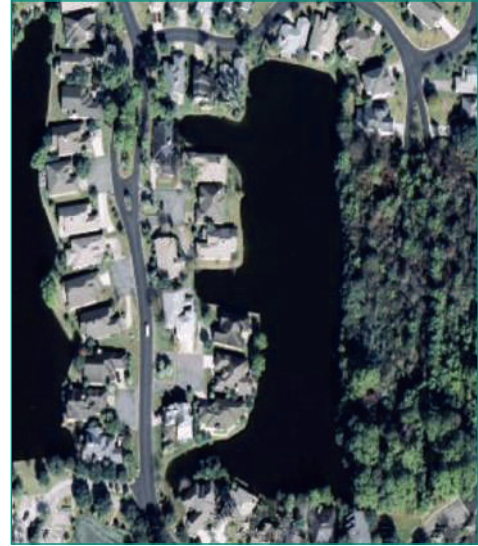
Fig. 6.: Aerial view of lake #2

Lake #2 is a 2-acre lake connected to Lake #1 by one culvert. Heavy loading from lawn care companies, run-off, natural debris, and development on the east bank have degraded the water quality. There is no Intercoastal Waterway.

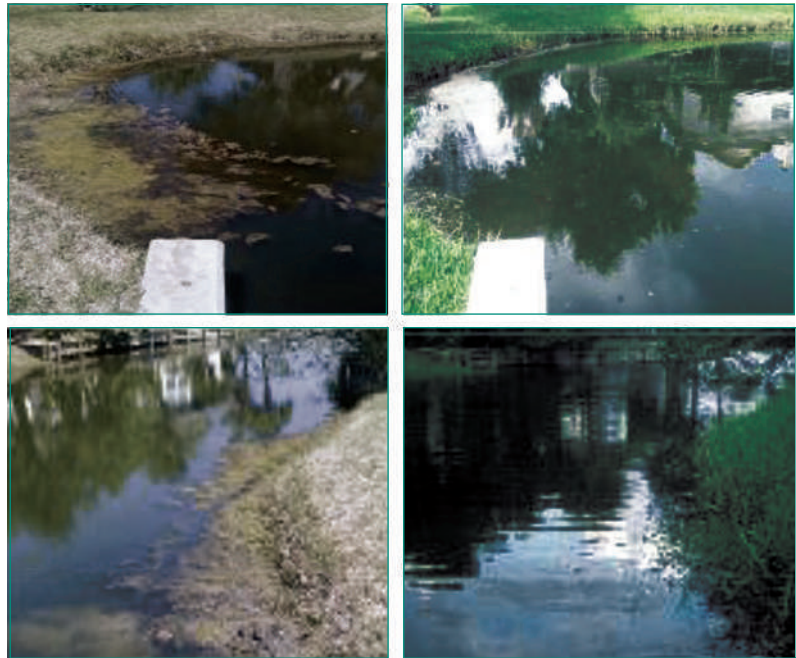
Fig. 7: Based on “before treatment” pictures on the left and “after treatment” pictures on the right, MICROBE-LIFT® treatments were very successful in #2.

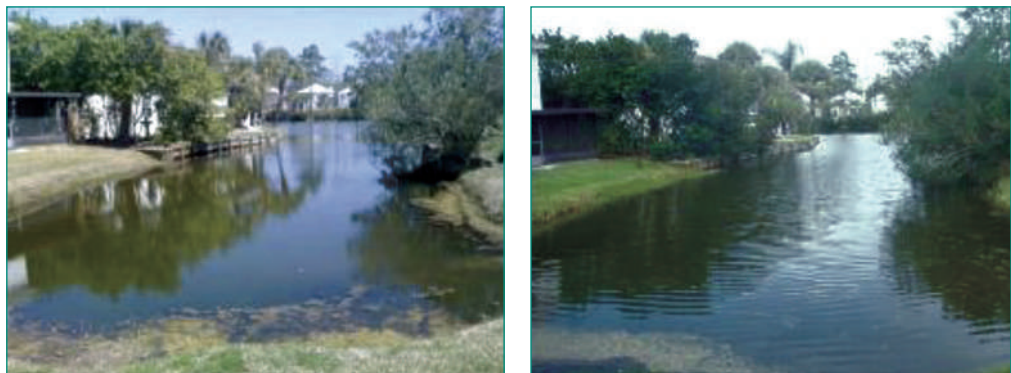
Fig. 8: Additional “before” (left) and “after” (right) pictures of lake #2.

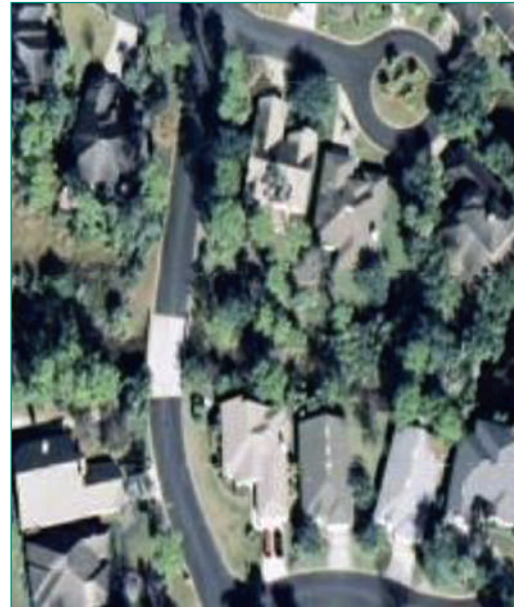
The creek and Lake #3 make an hourglass shape as seen on the right of this aerial view. This lake is fed by a creek from the Intercoastal Waterway transferring under the road as seen by the white section in this view. The creek is impaired at low tide by accumulated bottom solids of approximately 3 ft. Moderate load from lawn care and heavy load of natural debris are targeted for remediation.

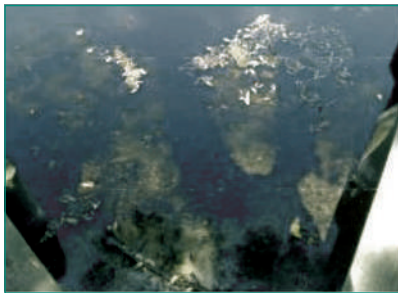
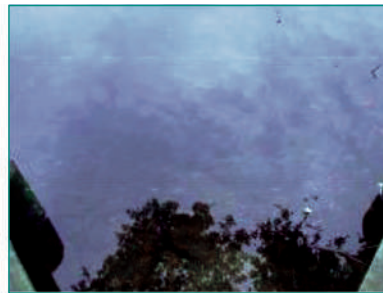
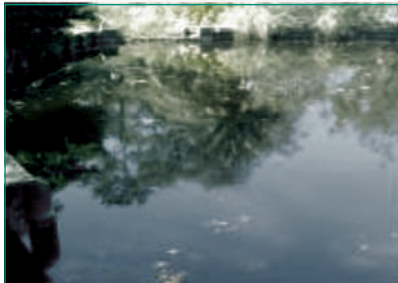
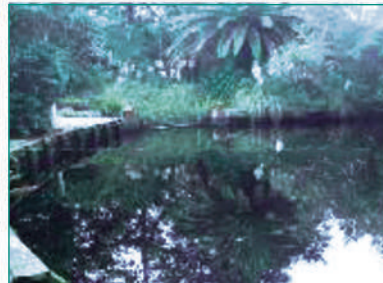
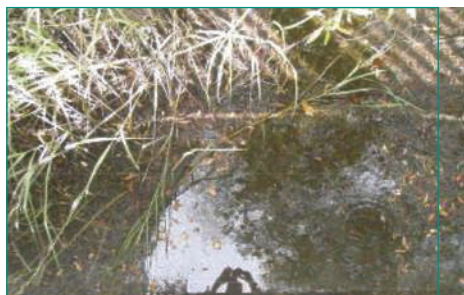
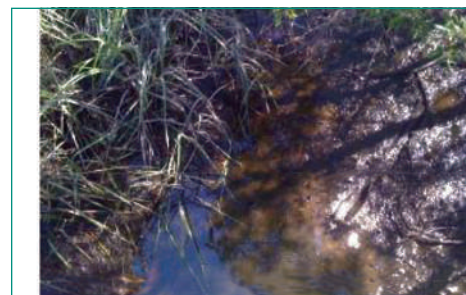
Fig. 10: Lake #3 also shows dramatic results from MICROBE-LIFT® treatment. Pictures prior to treatment on the left show organic surface pollution and scum, which is no longer present in pictures of treated lake on the right.

Fig. 11: The adjoining creek also showed benefits of treatment.

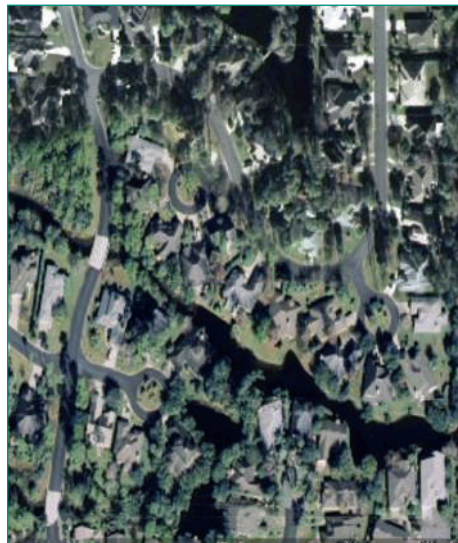
This one-acre lake is fed by a tidal creek from the Intercoastal Waterway. It is an elongated lake with the creek running under the white section in this aerial view. Heavy bottom solids have accumulated on the eastern section of the lake. There is good flow from the tidal creek to the Intercoastal Waterway.

Fig. 12: Aerial view of Lake #4 and the creek feeding it.

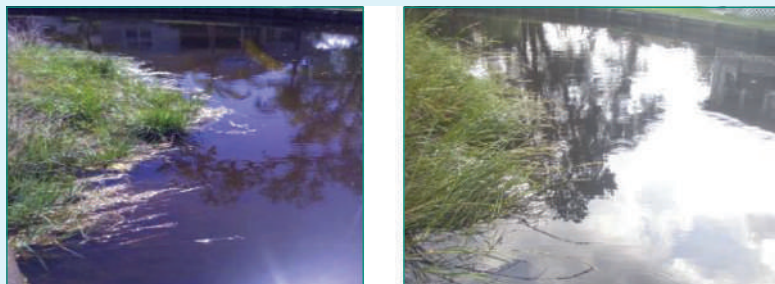
Fig. 13: Before and after pictures show results of treatment in Lake #4. Surface scum visible in “before” pictures on left are no longer visible and water clarity has substantially improved. Bottom solids have also been reduced.

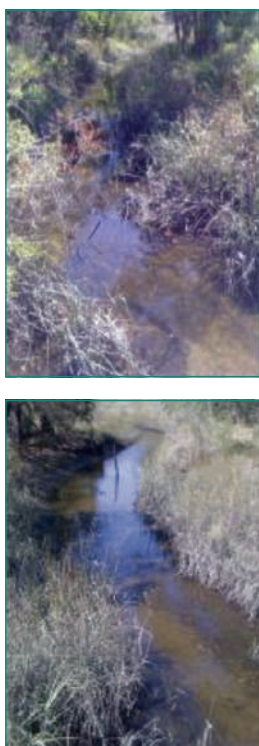
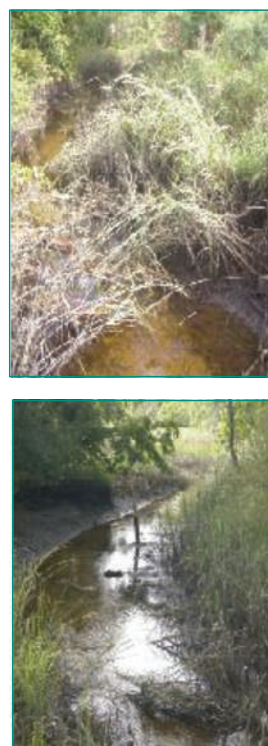
Fig. 14: Likewise the river responded to treatment with less scum and dramatically increased water clarity.

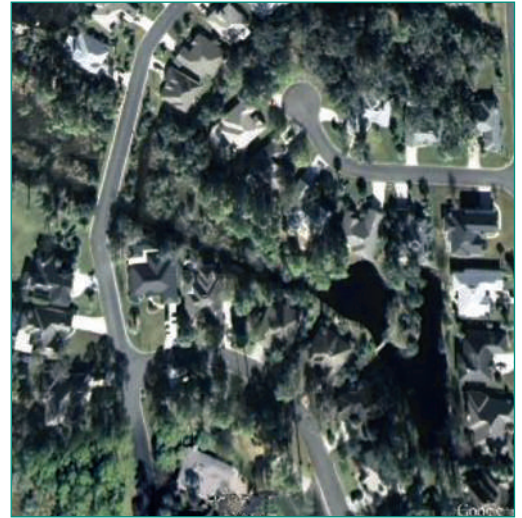
This is a 0.75-acre lake with a tidal stream that connects to the Intercoastal Waterway. Both the lake and creek have moderate to heavy bottom solids. There is a heavy load from the accumulation of natural debris.

Fig. 15: The aerial view on the right shows the lake and the channel to the Intercoastal Waterway.

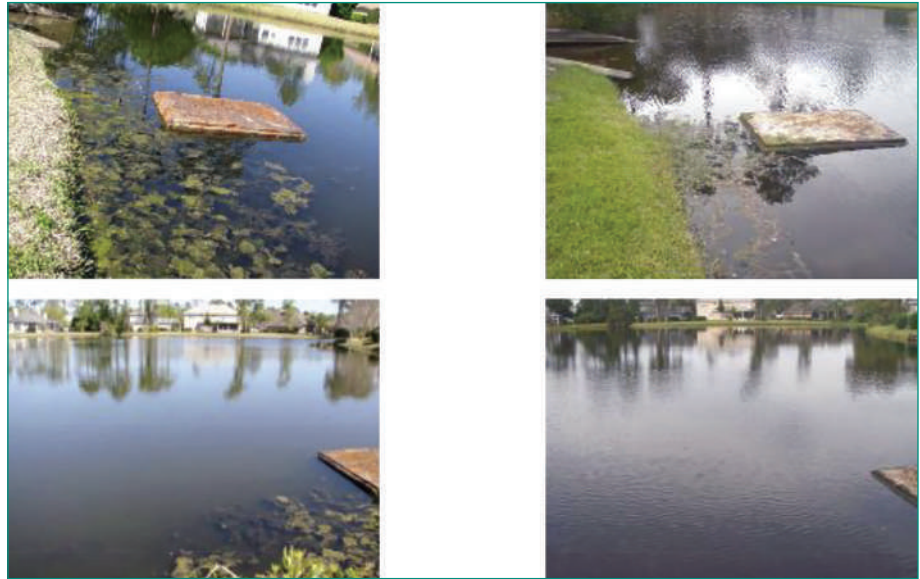
Lake 6 is a 1.5-acre lake with a spillway that flows into a creek totally obstructed by accumulated bottom solids that are overgrown with vegetation. This lake experiences moderate loading from lawn care, nutrient run off and natural debris.

Fig. 19: Note the scum in pictures of untreated lake (l eft), which are dramatically reduced or eliminated with treatment (right).

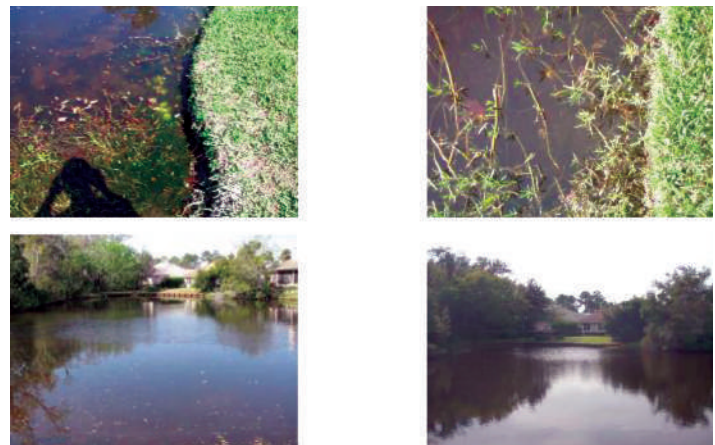
A 0.75-acre lake connected to storm drains from the street, this lake has no connection to the Intercoastal Waterway. There is a great natural wetland on the southern edge of the lake. This lake still suffers from collected debris and increased nutrients from nearby homes.

Fig. 20: Pictures demonstrate improved surface cleanliness and improved water clarity.
