MICROBE-LIFT® Technology Restores River in the Heart of Kuching City

Location: Sungai Bintangor River, Kuching, Sarawak, Malaysia

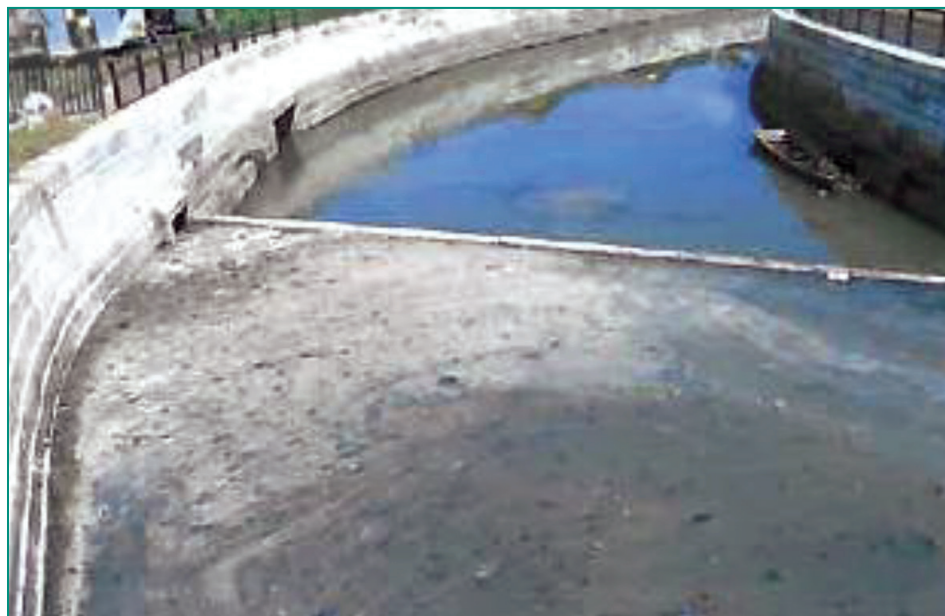
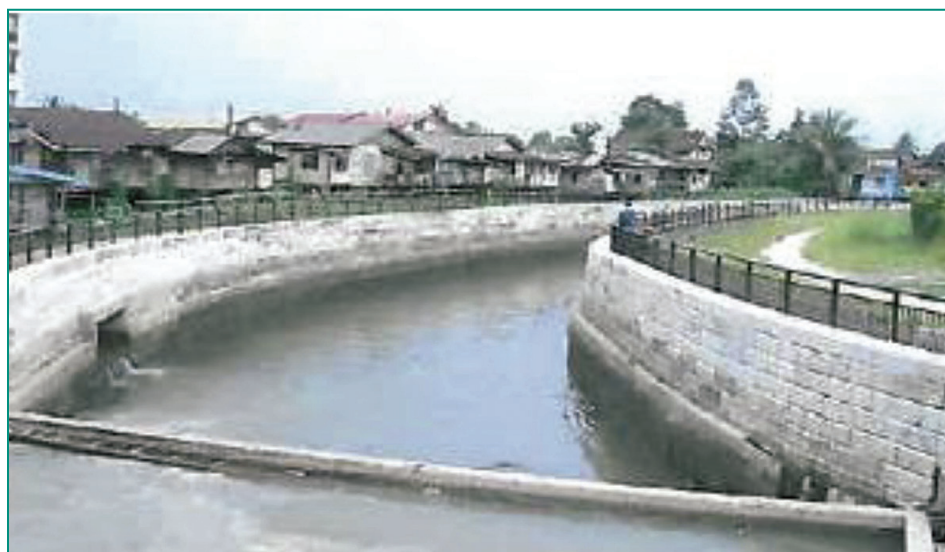
Fig 1 & 2: Pictures of Sg. Bintangor during low-level time prior to treatment in November 2007.

Although most of the larger solid wastes are collected in rubbish bins provided by City Hall, most of the smaller and wet, untreated and unfiltered wastes, oils and greases, are washed down the culverts and storm drains, eventually ending up at the weir areas of Sungai Bintangor. Most of the time the weir area is covered in an ugly layer of smelly, dirty, and unsightly layer of grease scum.

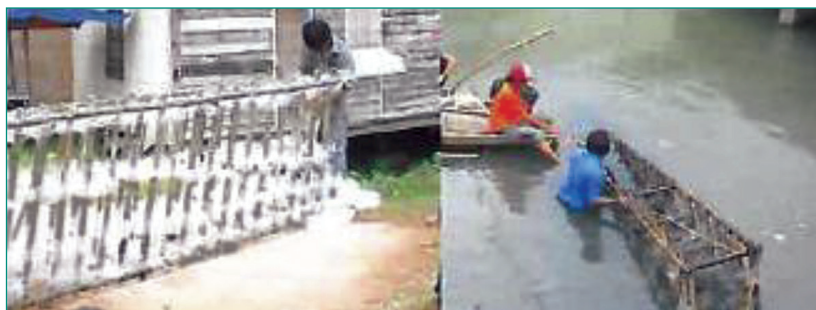
Fig.4: Shows the installation of the bioremediation cages in the river.

Any successful remediation of this site has to be two-phased. The city is challenged to change practices of those discharging into the river while a program of bioremediation with MICROBE-LIFT® Technology was designed to help remove scum and soluble organics in the river stream. Due to the very low retention time in a flowing stream, AEM designed a system of biomedica cages which were installed at the weir area and at strategically located points along the full length of the river to retain as much microbial biomass as possible during heavy rain and in the presence of high and ebbing tides.

A permanent weir had been constructed at the upstream section of Sg. Bintangovr near the road bridge to trap solid debris. The weir maintains the water level upstream at about 1.5m depth consistently and prevents the inflow of water from Sg. Sarawak. The water upstream the weir serves as an ideal location for the incubation of bacteria
